## CAA112(r) INSPECTION REPORT

<b>Name:</b> Sysco St. Louis, LLC	
<b>Address:</b> 3850 Mueller Road, St. Charles, Missouri 63301	<b>Date of Inspection:</b> March 8, 2018
<b>County:</b> St. Charles	<b>Case No:</b> 18MO0308
<b>Phone:</b> 636-940-9230	<b>RMP No:</b> 1000 0019 7468
<b>High Risk:</b> No	<b>FRS No:</b> 1100 1444 3940
<b>CAA Title V:</b> No	<b>Program Level:</b> Program 3
<b>Mailing Address:</b> 3850 Mueller Road, St. Charles, Missouri 63301	
<b>Process:</b> Anhydrous ammonia used for refrigeration

**Sysco St. Louis, LLC  
St. Charles, Missouri**

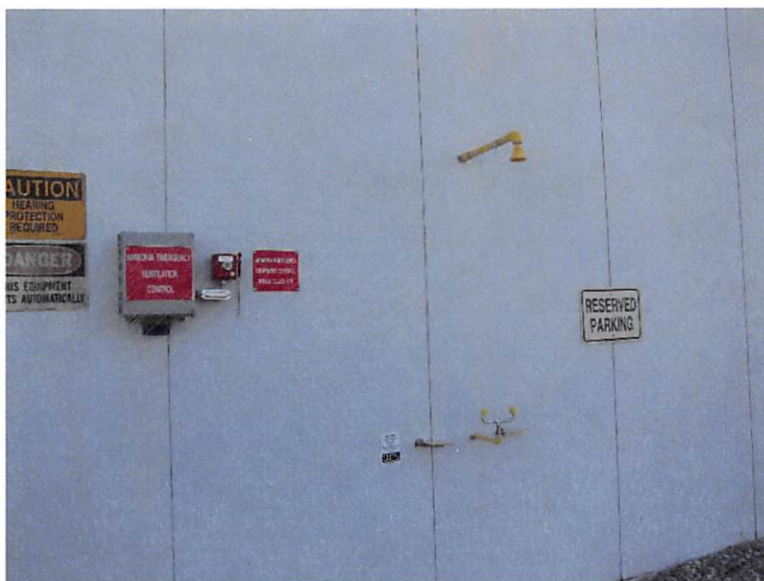
CASE NO. 18MO0308  Direction: South	DESCRIPTION	This photograph shows an emergency shower/eye wash station and an emergency ventilation control box immediately outside the engine room.	1
	FACILITY	Sysco St. Louis, LLC	Date
	PHOTOGRAPHER	Robert Monnig	3/8/2018

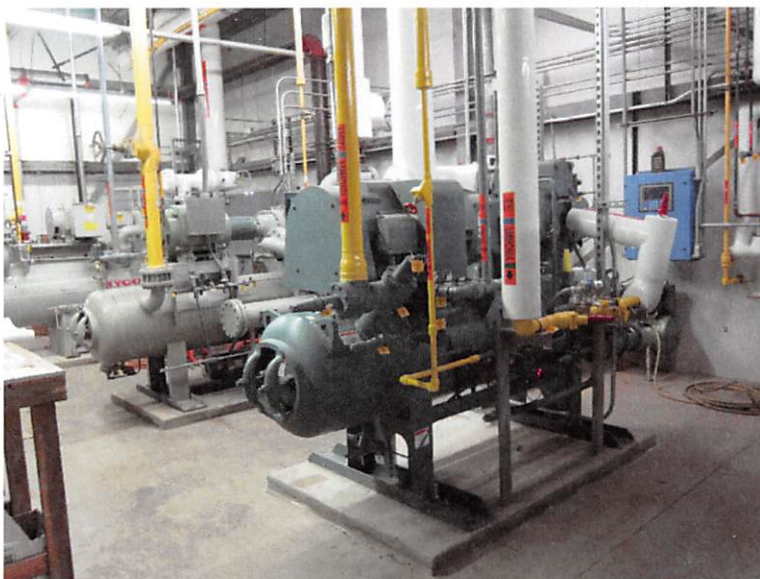
CASE NO. 18MO0308  Direction: West	DESCRIPTION	This photograph shows compressors in the engine room.	2
	FACILITY	Sysco St. Louis, LLC	Date
	PHOTOGRAPHER	Robert Monnig	3/8/2018

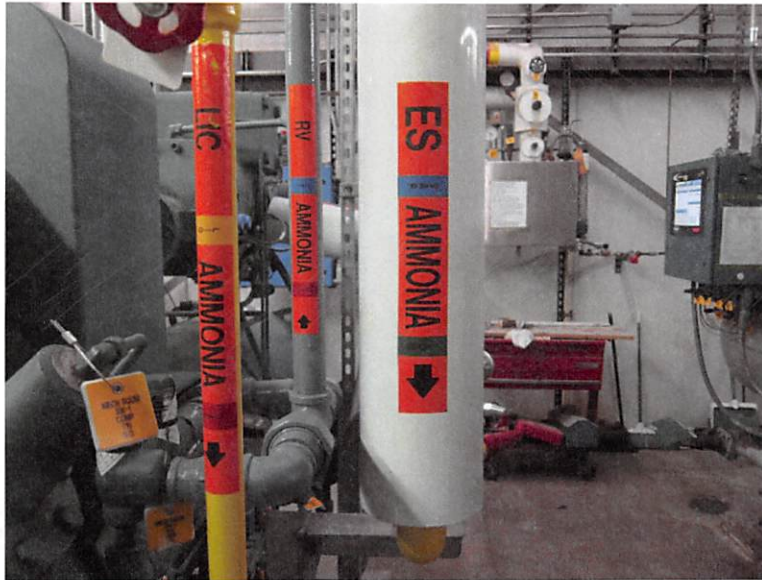
CASE NO. 18MO0308  Direction: NA	DESCRIPTION	This photograph shows typical piping labeling observed in the engine room.	3
	FACILITY	Sysco St. Louis, LLC	Date
	PHOTOGRAPHER	Robert Monnig	3/8/2018

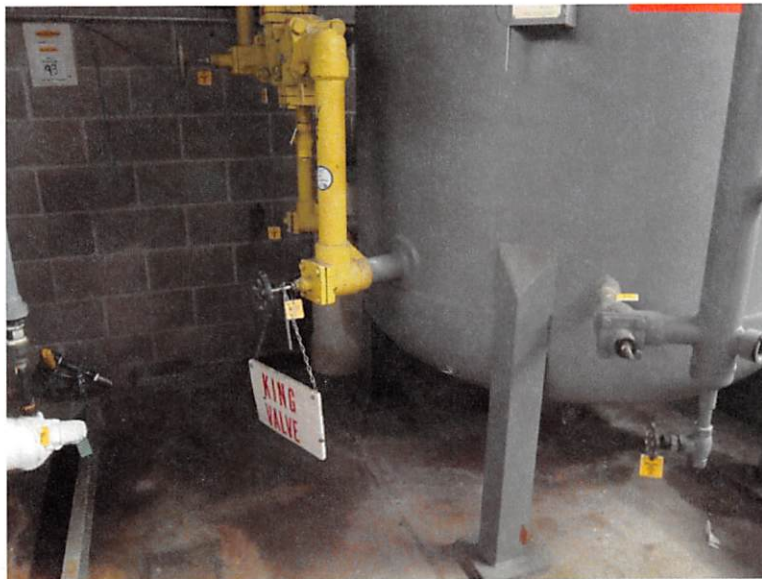
CASE NO. 18MO0308  Direction: NA	DESCRIPTION	This photograph shows the high-pressure receiver and the labeled king valve.	4
	FACILITY	Sysco St. Louis, LLC	Date
	PHOTOGRAPHER	Robert Monnig	3/8/2018

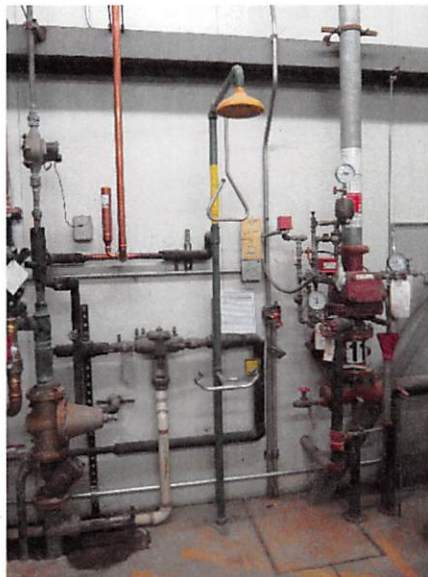
CASE NO. 18MO0308  Direction: NA	DESCRIPTION	This photograph shows an emergency shower/eye wash station in the engine room.	6
	FACILITY	Sysco St. Louis, LLC	Date 3/8/2018
	PHOTOGRAPHER	Robert Monnig

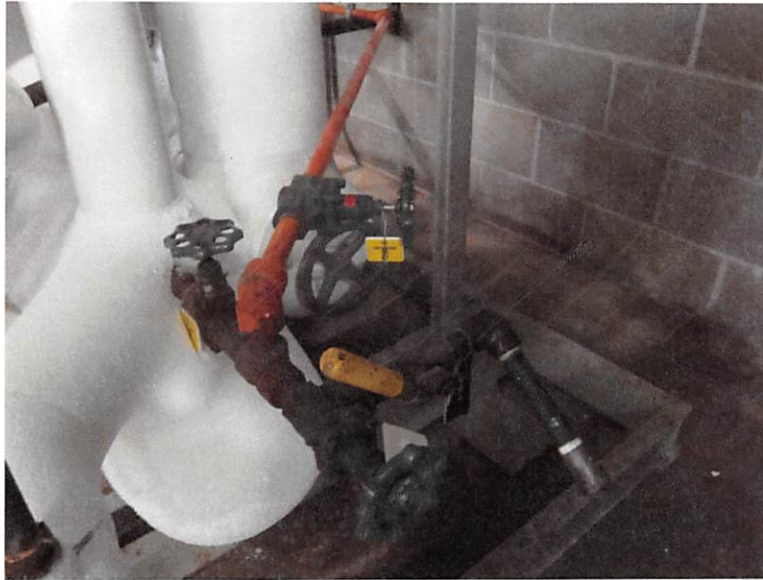
CASE NO. 18MO0308  Direction: NA	DESCRIPTION	This photograph shows an oil pot equipped with a self-closing valve. A shut-off valve is installed in series with the self-closing valve.	7
	FACILITY	Sysco St. Louis, LLC	Date
	PHOTOGRAPHER	Robert Monnig	3/8/2018

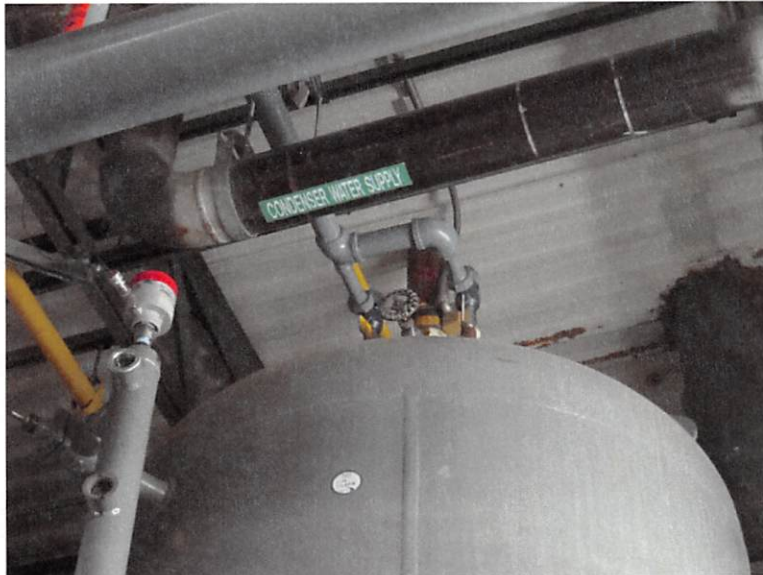
CASE NO. 18MO0308  Direction: NA	DESCRIPTION	This photograph shows dual relief valves installed on the high-pressure receiver.	8
	FACILITY	Sysco St. Louis, LLC	Date
	PHOTOGRAPHER	Robert Monnig	3/8/2018

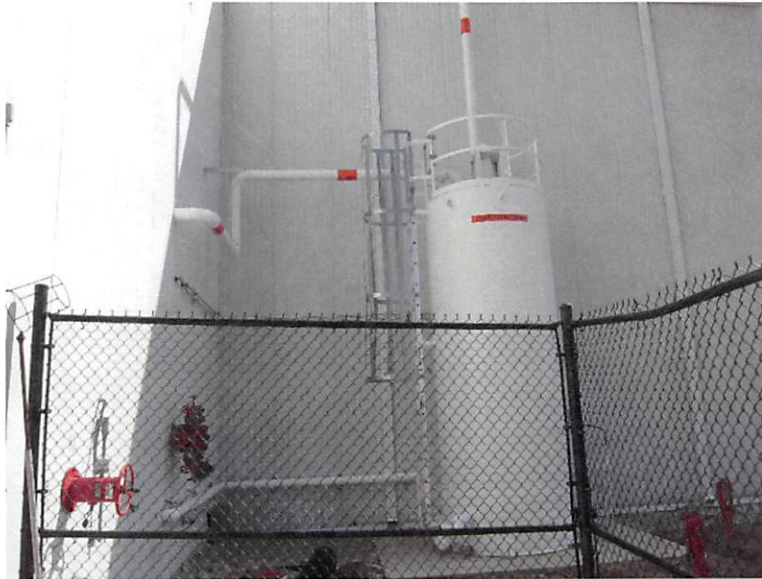
CASE NO. 18MO0308  Direction: Southeast	DESCRIPTION	This photograph shows the water-filled dispersion tank outside of the engine room. Relief valves in the engine room are routed to this dispersion tank.	9
	FACILITY	Sysco St. Louis, LLC	Date
	PHOTOGRAPHER	Robert Monnig	3/8/2018

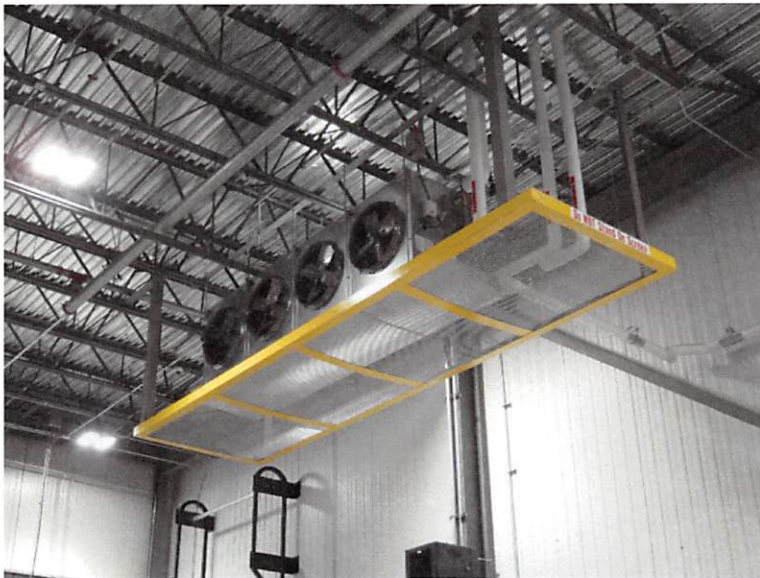
CASE NO. 18MO0308  Direction: NA	DESCRIPTION	This photograph shows an evaporator that was installed during the facility's 2017 expansion.	12
	FACILITY	Sysco St. Louis, LLC	Date 3/8/2018
	PHOTOGRAPHER	Robert Monnig

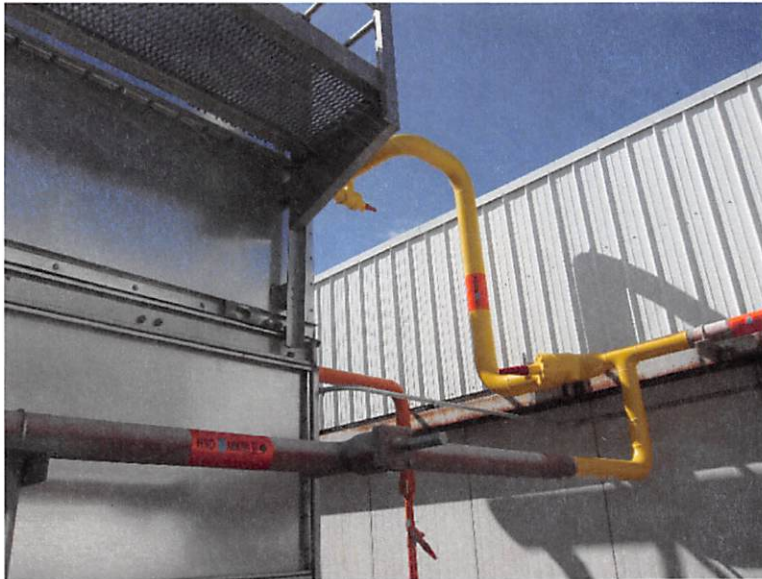
CASE NO. 18MO0308  Direction: NA	DESCRIPTION	This photograph shows typical labeling of anhydrous ammonia piping on the roof of the facility.	13
	FACILITY	Sysco St. Louis, LLC	Date
	PHOTOGRAPHER	Robert Monnig	3/8/2018

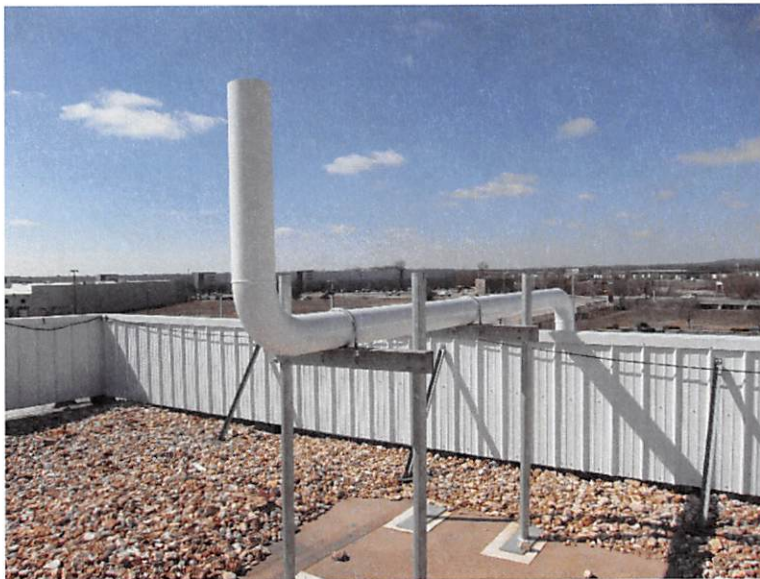
CASE NO. 18MO0308  Direction: West	DESCRIPTION	This photograph shows the termination of the diffusion tank vent line.	14
	FACILITY	Sysco St. Louis, LLC	Date
	PHOTOGRAPHER	Robert Monnig	3/8/2018

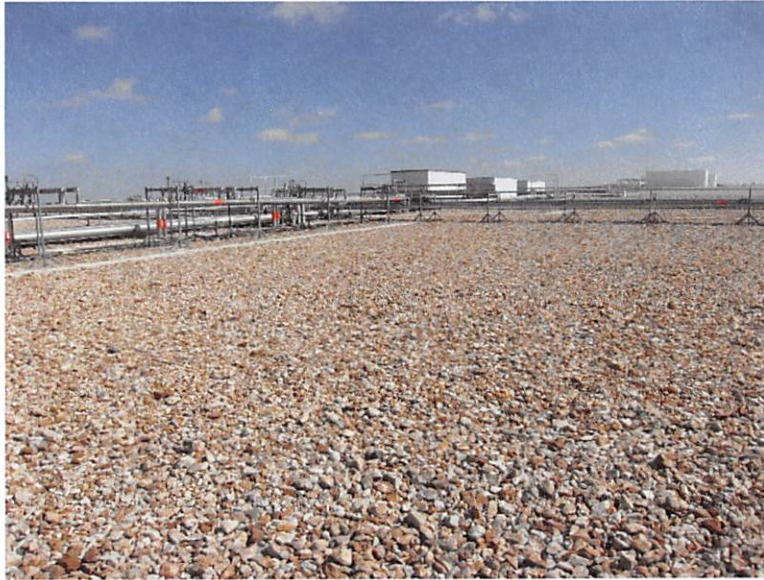
CASE NO. 18MO0308  Direction: West	DESCRIPTION	This photograph shows typical ammonia piping and piping support on the roof of the facility.	15
	FACILITY	Sysco St. Louis, LLC	Date
	PHOTOGRAPHER	Robert Monnig	3/8/2018
